*** TECHNICAL EVALUATION ***

1) Fall HVAC System Evaluation Checklist:

SYSTEM # 2 UPSTAIRS:

***MODEL NUMBER: PG8MAA066110ADJA
SERIAL NUMBER: 1510A14867***

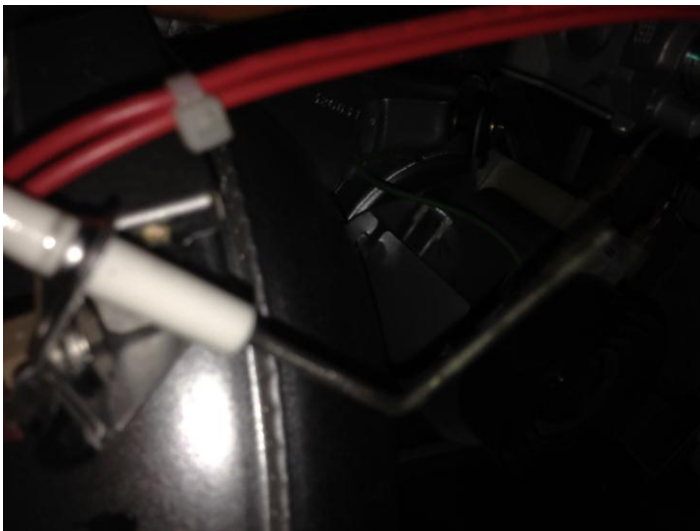
Figure a

- **System initiated its startup sequence properly and ran as it was designed. Flame profile is shown in figure (c).**
- **Flame sensor was cleaned with sandpaper as shown in figure (a).**
- **Cleaned out combustion-air pressure sensor intake line**
- **Overall the system is old and has many of its original controls equipment on it. While it is running good now the age of the control devices are to be dually noted.**
- **Figure (d) shows the old filter that was in the system that was damaged from UV light.**
- **Figure (e) indicated the proximity from the UV light to the filter, which is why the filter has been damaged. This installation is incorrect the UV light is meant to clean the air and clean the evaporative coil and thus should be installed on the other end of the system**
